Manhole Inspection Summary

Manhole # S11Y__008MH

Insp Date: **4/11/08 8:45 AM**

Location Address: **1201 Bloomfield Ave**

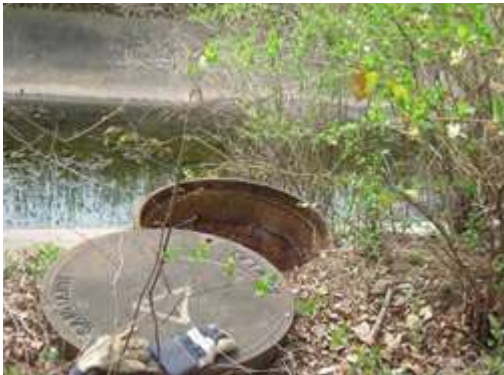
Location View

Near exit 48B S. Caton

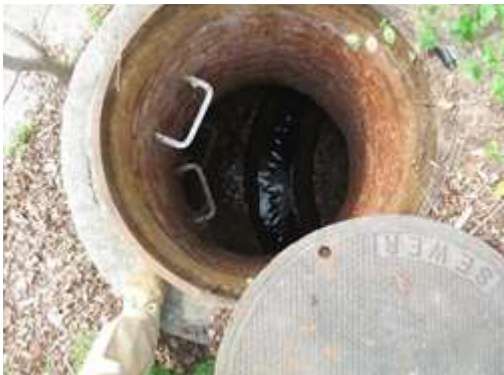
Frame View

Frame Offset: **0** (in.) Condition: ☒ Sound ☐ Cracked ☐ Leaks

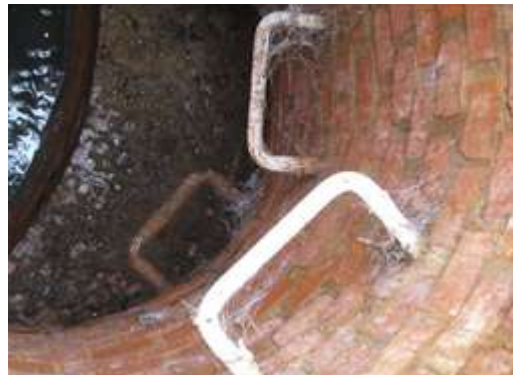
Defect 1

Steps Count: **3** Missing: **0** ☒ **Corroded**

Corroded steps

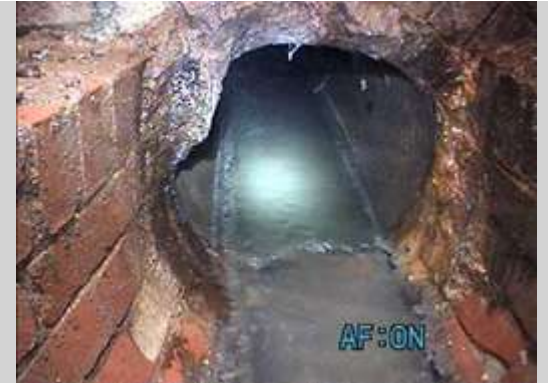
12 O'Clock Outflow

15 in. Circular Gravity Sewer
Pipe Out @ 12 O'Clock

Pipe Height: **15.6** (in.) Rod and Bar (Angled)
Pipe Material: **Clay** ☐ Pipe Lined
Invert Depth: **9.17** (ft.) Flow Characteristics: **Slow**
Deposits: ☒ None ☐ Mud ☐ Sludge ☐ Debris ☐ Grease
Silt Depth: **0** (in.) Deposits Extent:
Infiltration: **Evidence** Pipe Seal Cond: **Unknown**

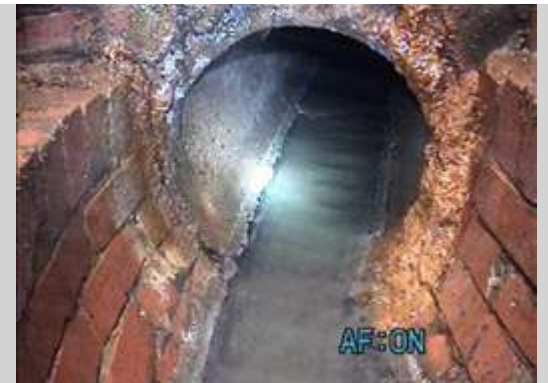
5 O'Clock Inflow

15 in. Circular Gravity Sewer
Pipe In @ 5 O'Clock

5 O'clock connection is actually a 7

Pipe Height: **15.6** (in.) Rod and Bar (Angled)
Pipe Material: **Clay** ☐ Pipe Lined
Invert Depth: **9.17** (ft.) Flow Characteristics: **Slow**
Deposits: ☒ None ☐ Mud ☐ Sludge ☐ Debris ☐ Grease
Silt Depth: **0** (in.) Deposits Extent:
Infiltration: **Evidence** Pipe Seal Cond: **Unknown**
